RE: Roof Snow Loads
Maintenance Facility Building
Oyster River Cooperative School District
Durham, NH

At your request Emanuel Engineering, Inc. visited the Oyster River School District Maintenance Facility located at 33 Coe Drive, Durham, NH on February 18, 2015, to investigate possible roof problems due to snow loads on the roof. Dave Emanuel and I met with you on site. This report summarizes our observations and recommendations.

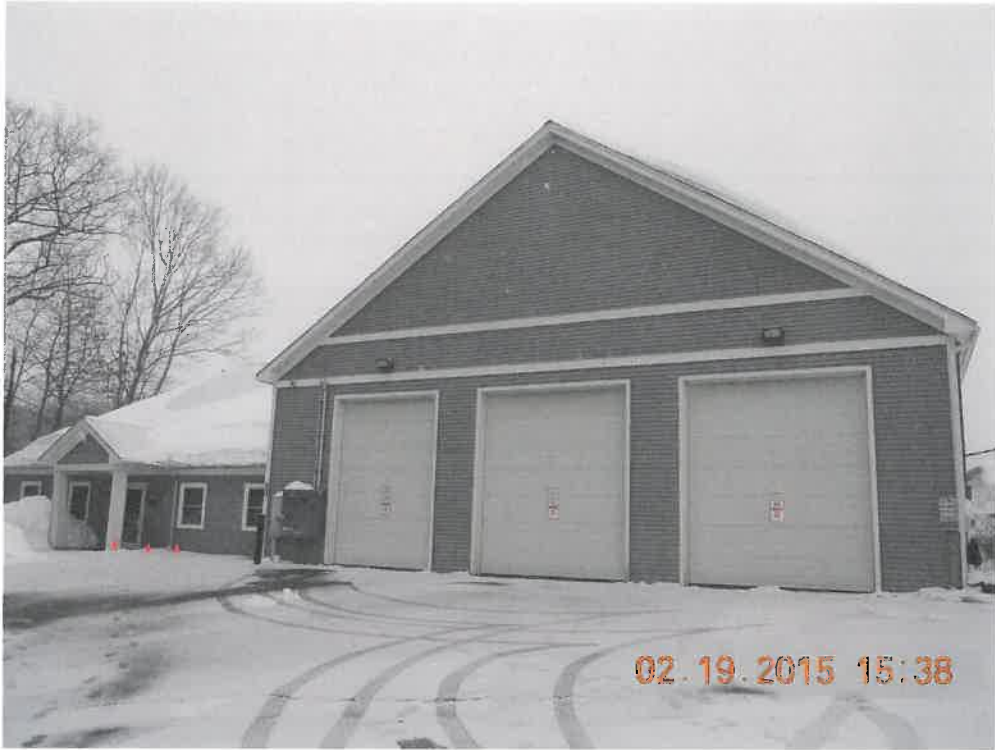
Maintenance Facility Building

There was no apparent over burdening snow load on the 1½ story building at the time of the inspection. Building plans of the building were not provided by the School District nor reviewed for design loads.

Without further additional review, calculations, or inspections, we recommend that snow depths on the maintenance building roof not exceed 24 inches. Based on the day of the visit, snow depths appear to be within allowable depths.

It is recommended that the attic space above the garage be checked for proper bracing of the wood trusses and potential damage. Also, the attic space / rafters over the office space should be made accessible and inspected to check for rafter / truss damage due to unbalanced snow load and sliding snow conditions. Add a scuttle for access to attic above the office area.
